Rhine

between km: 335.92 Iffezheim

and km: 352.07 (border Germany/France)

- Binnenwasserstraßenabschnitt mit besonderen Risiken

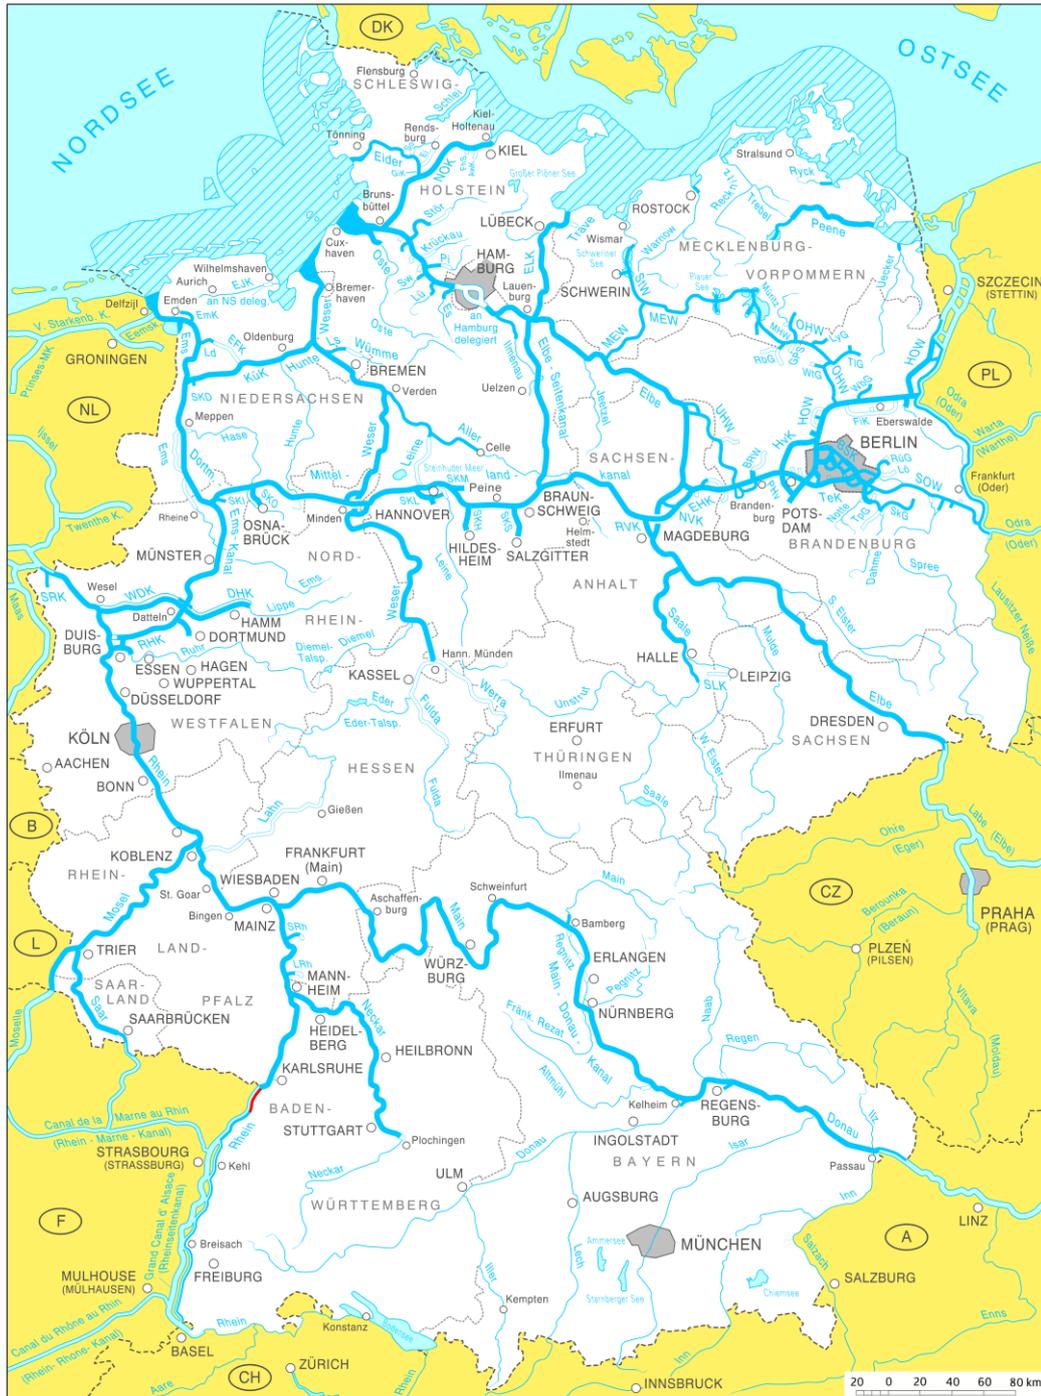
Quelle: Fachstelle für Geodäsie und Geoinformatik, Regensburg (Kartographie), zur Verfügung gestellt gemäß GeoNutzV  
Bundeswasserstraßen, die eine Länge von unter 5 km aufweisen, sind maßstabsbedingt teilweise nicht dargestellt.

On the stretch between the Iffezheim/Wintersdorf lock (Rh/km 335.92) and the border between Germany and France (Rh/km 352.07), the Franco-German border runs longitudinally through the Rhine. Therefore, a joint notification in accordance with Article 9(3) of Directive 2017/2397 is required.

A designation of the Rhine between the Iffezheim/Wintersdorf lock (Rh/km 335.92) and the border between Germany and France (Rh/km 352.07) as a stretch of inland waterway with specific risks is required in accordance with Article 9 of Directive (EU) 2017/2397 for the safety of shipping. The origins of these risks are
